June 2, 2016

Re: Geotechnical Engineering Assessment of Dairy Farm Storage Pond Berm
4207 West Linwood Avenue, Turlock, California
SFB Project No.: 727-1

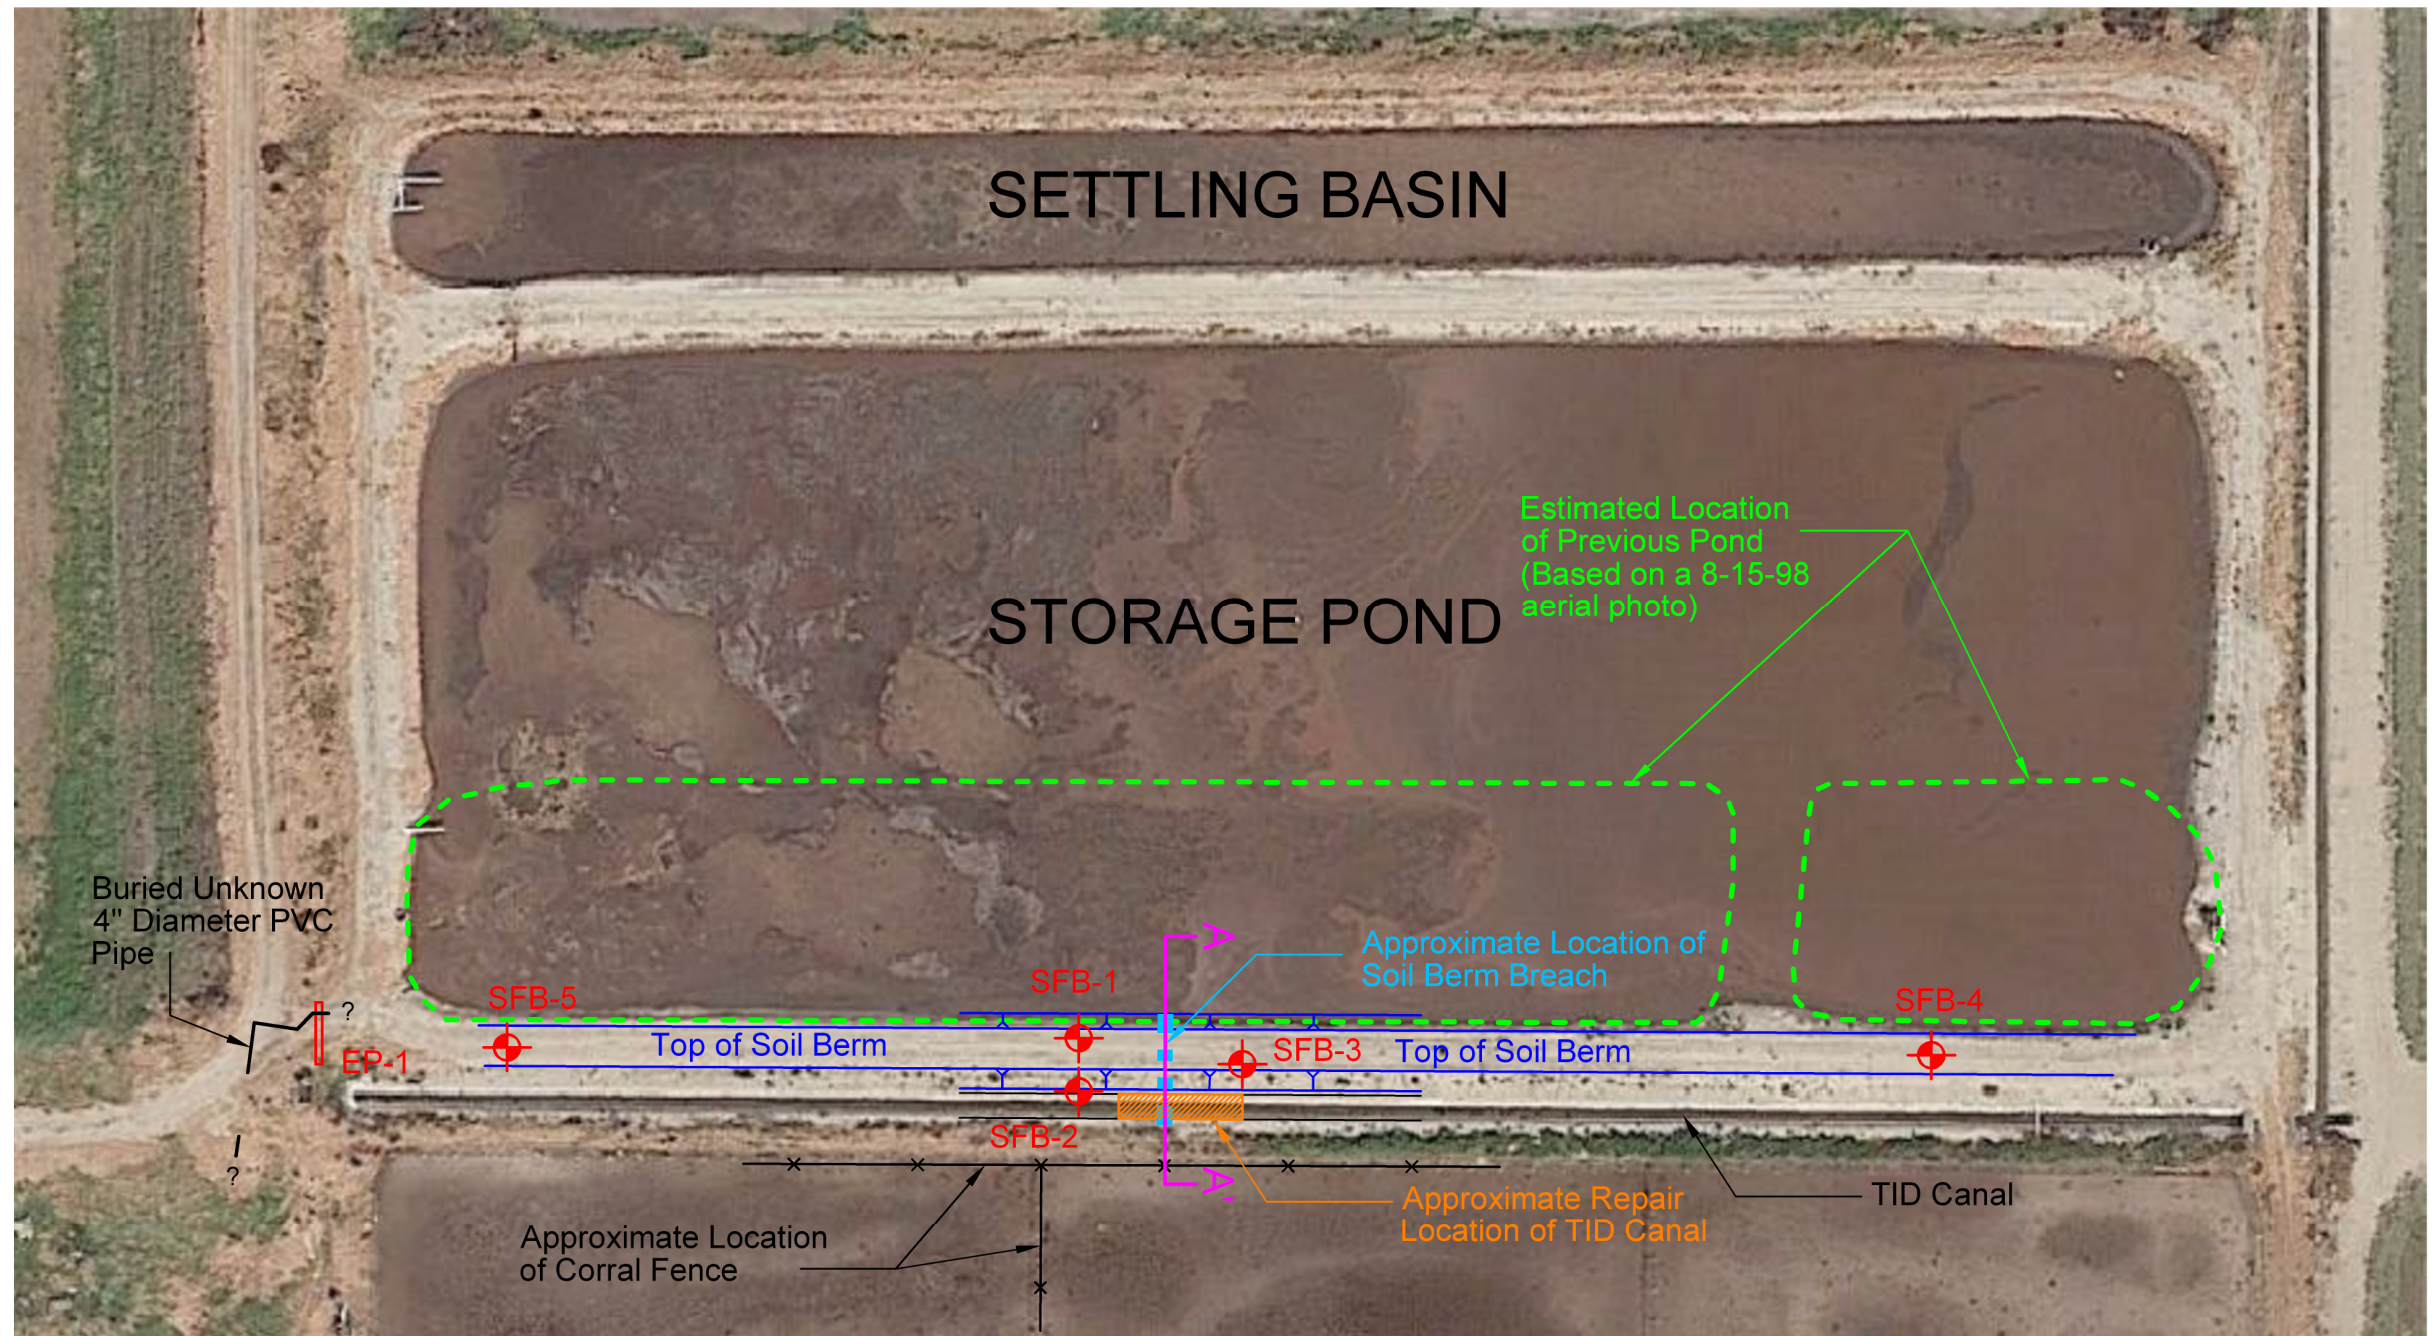
At the time of our site investigation on May 4, 2016 and as shown on Figure 1, the wastewater storage pond was located to the north of the dairy farm corral. The pond was rectangular in shape and had plan dimensions of about 590 feet by 220 feet. The bottom of the pond was estimated to be about 10 feet below the top of the surrounding berm. A concrete lined TID (Turlock Irrigation District) canal was located at the base (outboard side) of the southern berm.

It is our understanding that a breach of the southern berm occurred in the morning of November 20, 2015, which resulted in wastewater discharging to the areas south of the storage pond. After the breach, the storage pond was observed to have approximately 5-1/2 feet of freeboard. The approximate location of the breach is shown on Figure 1.

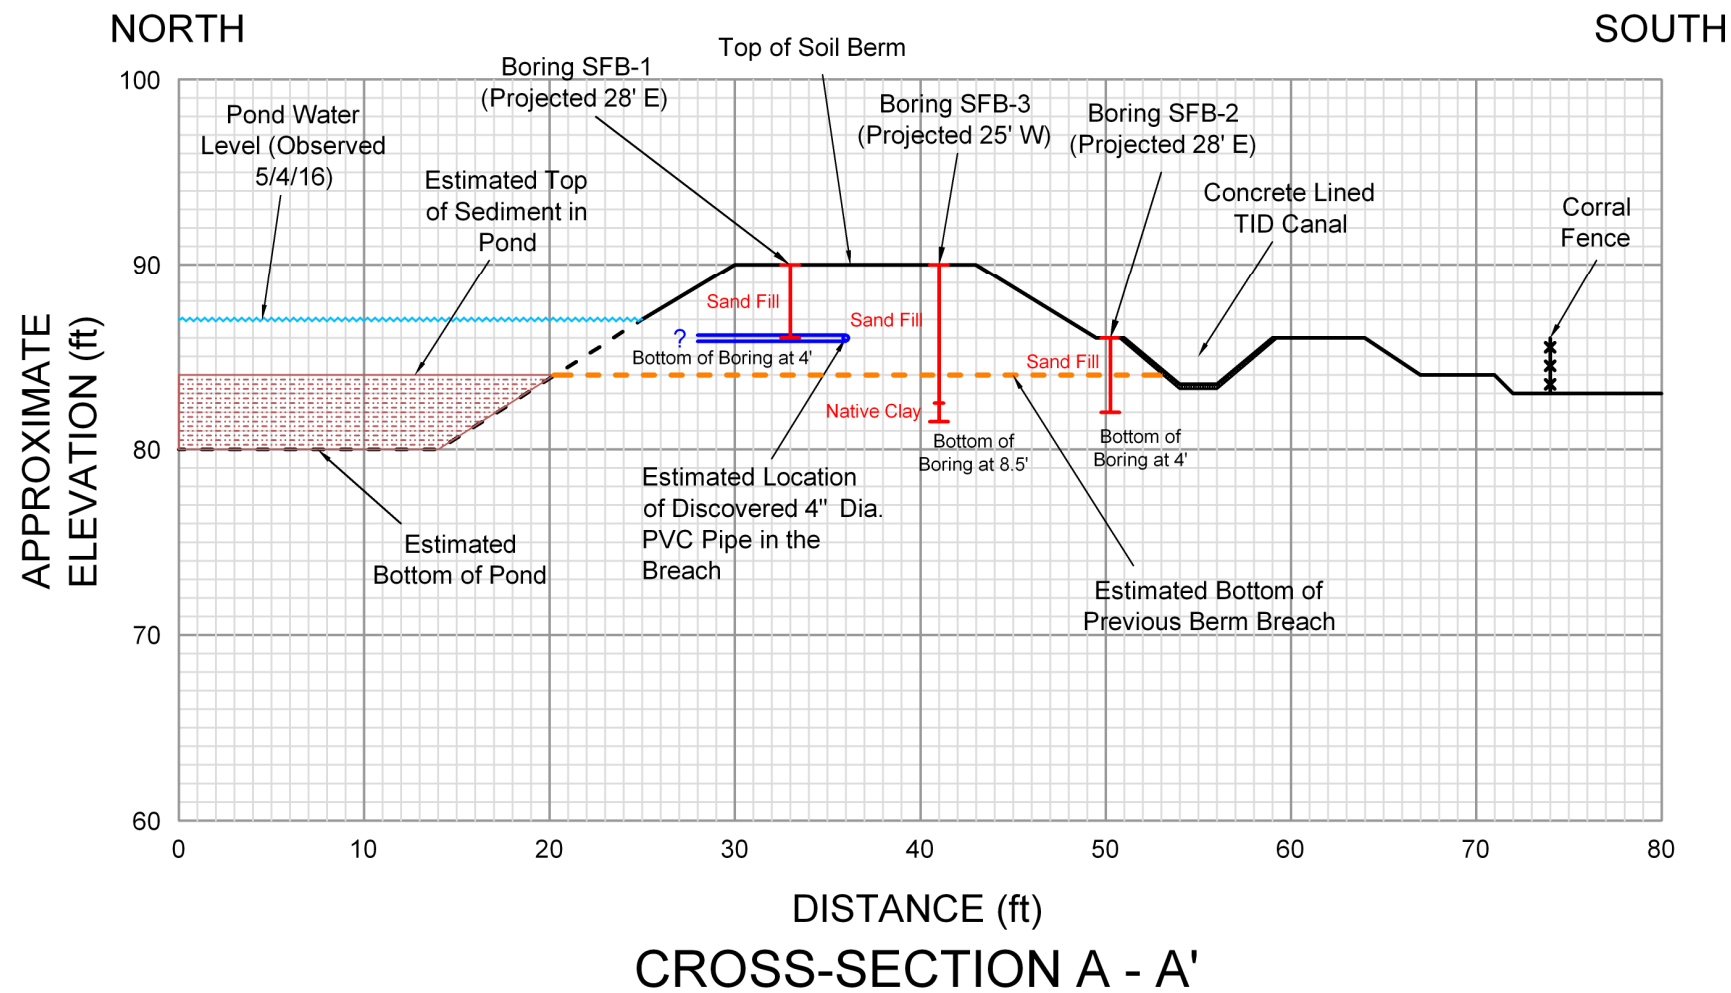
The table below summarizes the results of our slope stability analyses for Cross-Section A-A' (the southern berm where the breach occurred) under several loading conditions as described above. The cross-section profiles, soil engineering properties used in the analyses, and the detailed results of the analyses are presented on the computer program printouts in the attached Appendix C.

Case	Loading Conditions	Factor of Safety against Sliding	
		Static	Pseudo-Static (Earthquake Loading $k = 0.16$)
1	Pond Water Level at 3 Feet below Top of Berm with Partially Saturated Soil Berm	2.5	1.8
2	Pond Water Level at Top of Berm with Partially Saturated Soil Berm	2.3	1.6
3	Pond Water Level at Top of Berm with Totally Saturated Soil Berm	1.7	1.2*

The results of our analyses indicate that the factors of safety against sliding under static loading conditions for all cases are greater than the minimum acceptable value of 1.5. In addition, the factor of safety against sliding for Cases 1, 2, and 3 pass the screen criteria outlined in the SCEC publication (factor of safety greater than one) when applying a seismic coefficient of 0.16. Therefore, our slope stability analysis results show that the global and internal stability of the southern berm is acceptable.

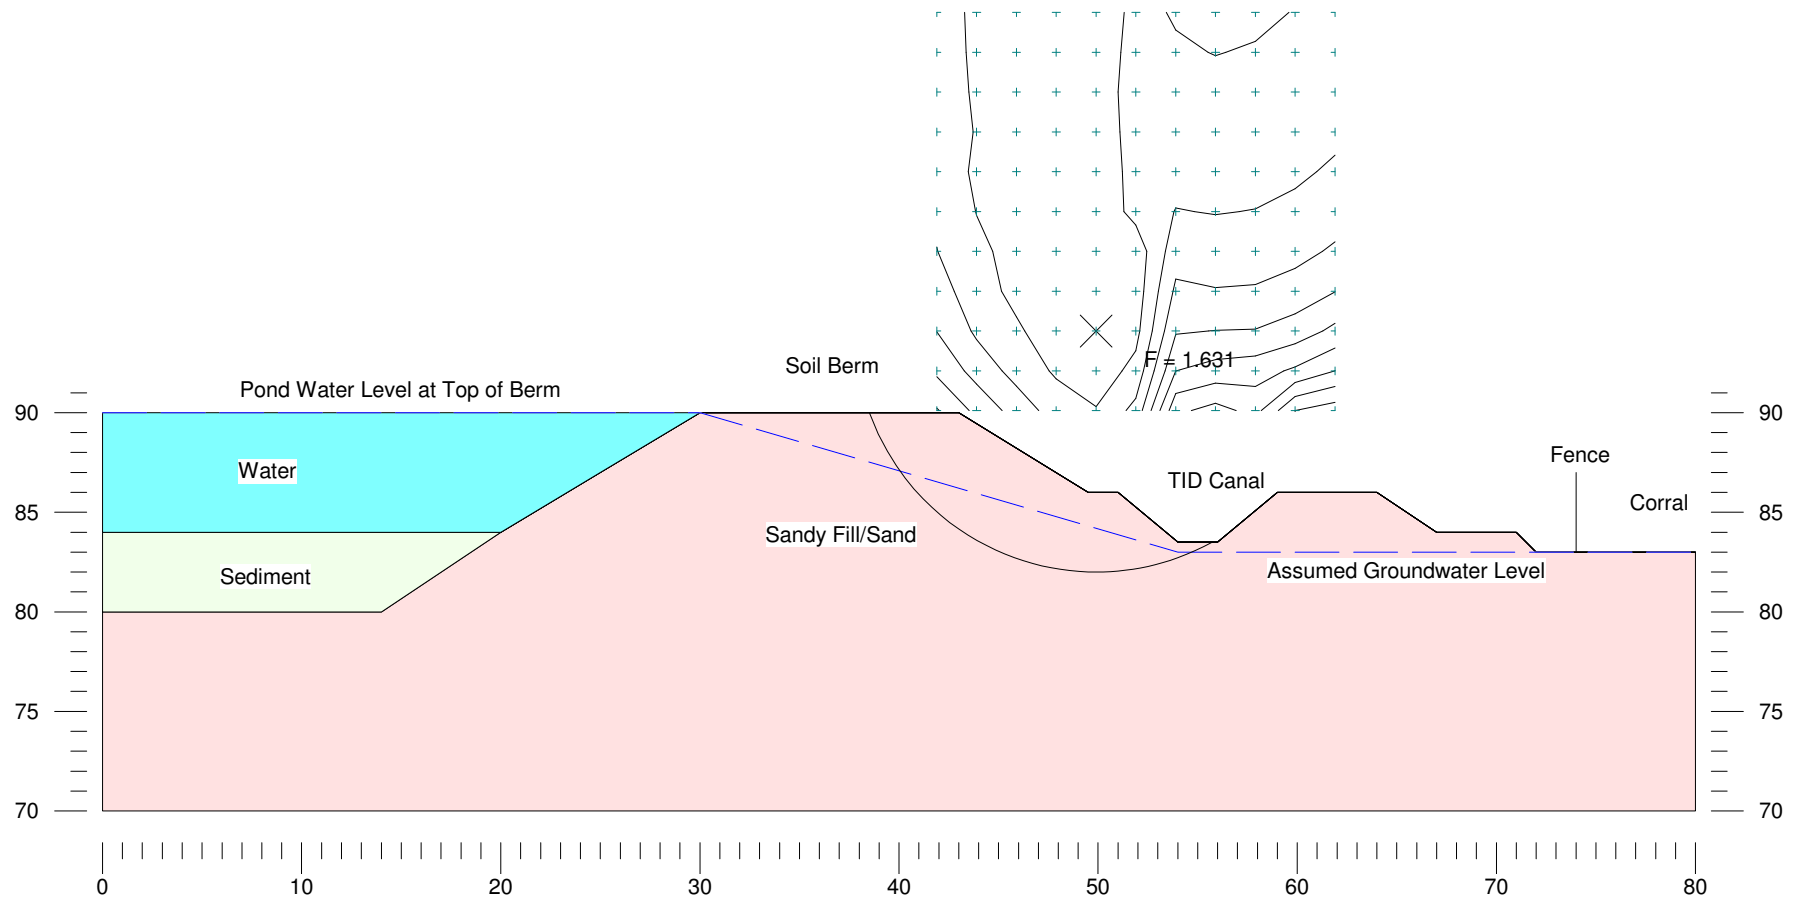
Stevens Ferrone & Bailey Engineering Co. Inc.
727-1
Dairy Farm Pond, 4207 West Linwood Ave
Turlock, CA
Pseudo-Static
Case 2: Pond Water at Top of Berm

5/13/2016 4:02:01 PM F:\PPBI7E~E\727-1\75CESP~RISE_RW.GSL Stevens Ferrone & Bailey Engineering Co. Inc. F = 1.631

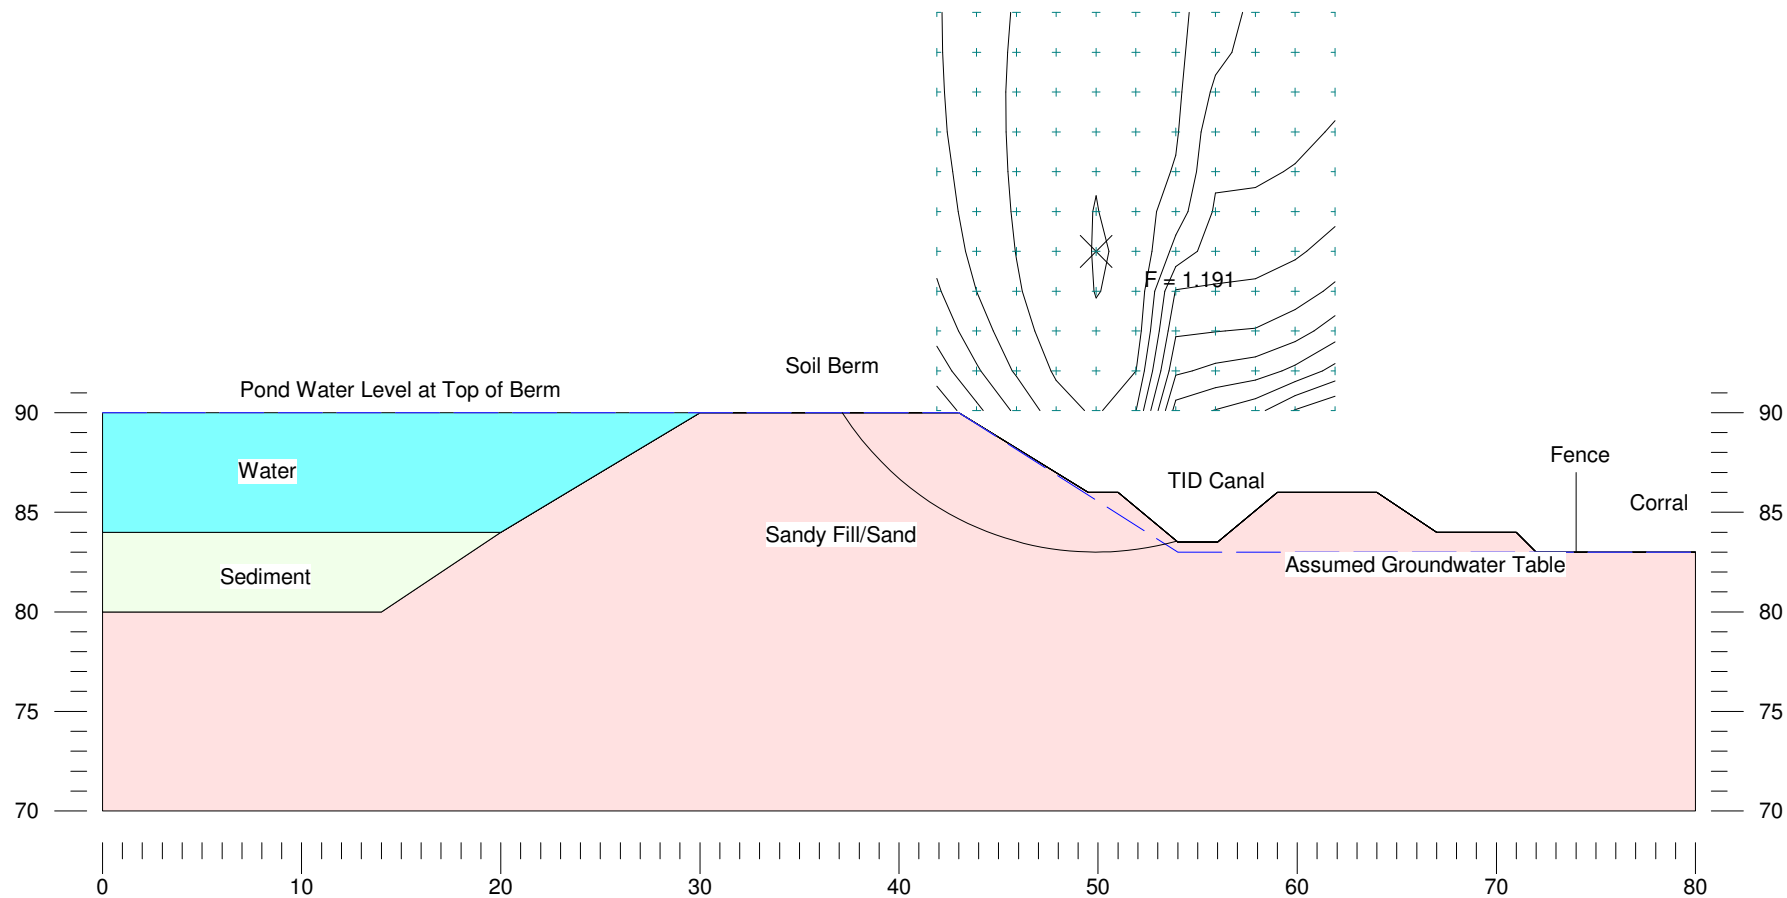
Stevens Ferrone & Bailey Engineering Co. Inc.
727-1
Dairy Farm Pond, 4207 West Linwood Ave
Turlock, CA
Pseudo-Static
Case 3: Saturated Soil Berm

*Note: This condition is highly unlikely since a major earthquake would have to occur at the same time the pond water is at the top of the berm and the entire berm is saturated.

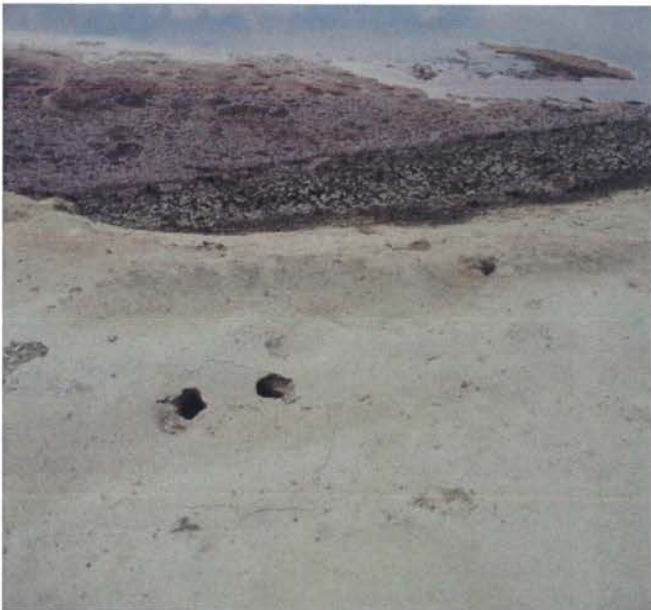
Phone 6: Holes on the berm of storage lagoon

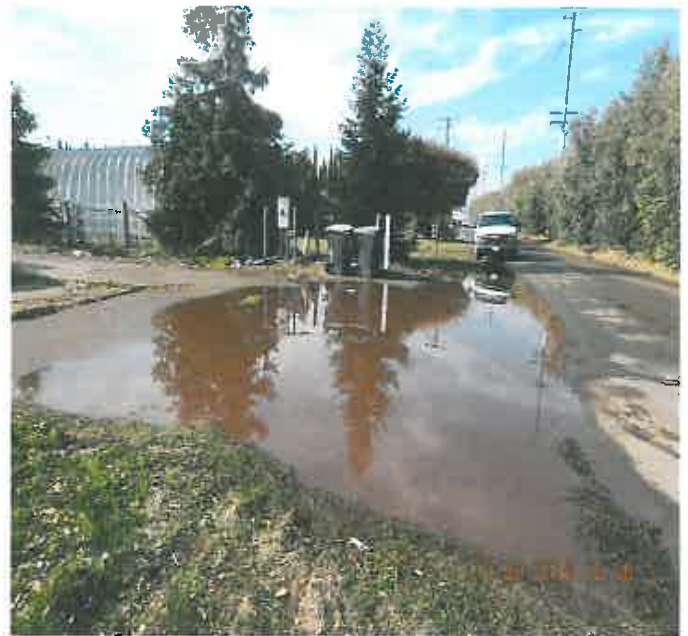
Photo 2: Wastewater ponding on south side of Linwood Avenue (east to west view)

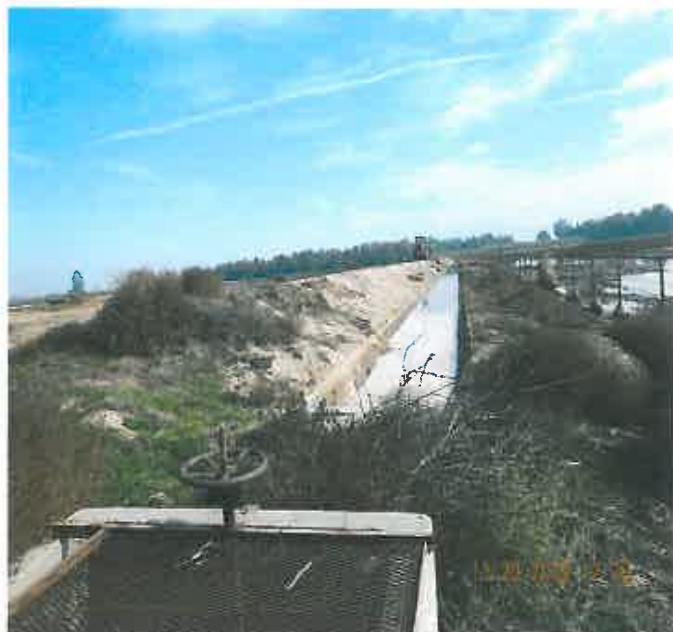
Photo 12: Wastewater in TID canal (south side of the lagoon; west to east view)

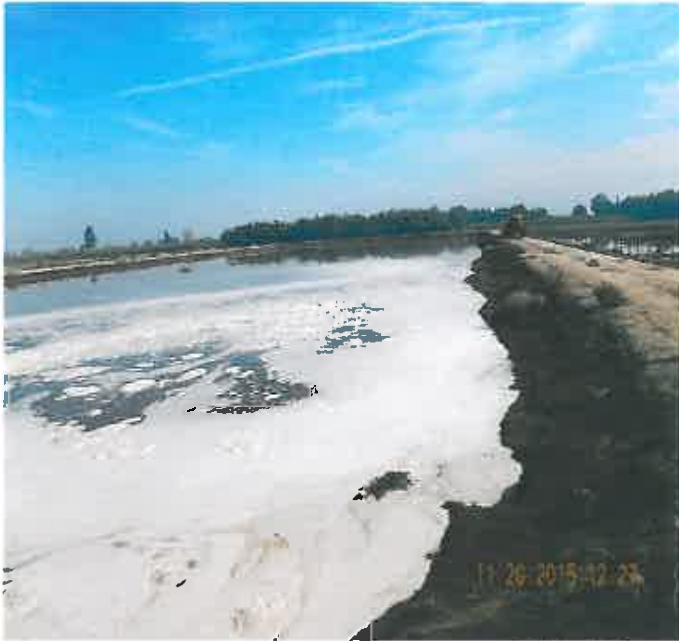
Photo 13: South side lagoon dropped 4 to 5 ft. due to the discharge

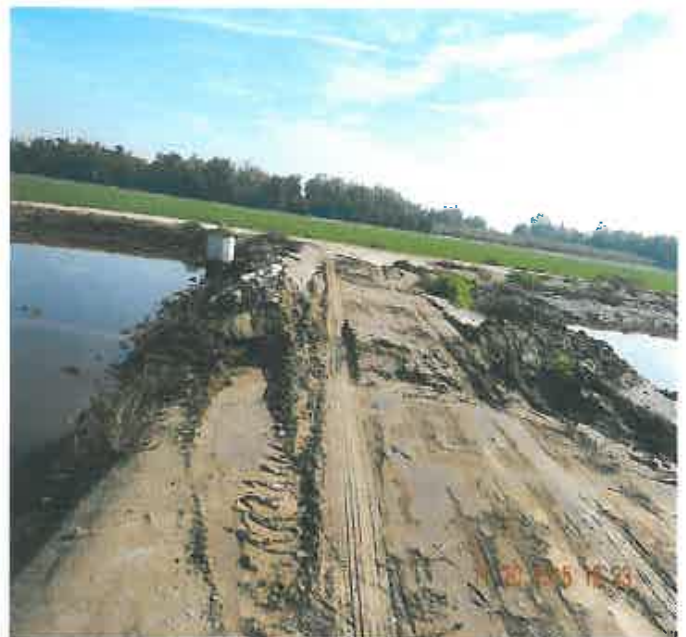
Photo 16: Wastewater from settling basin directed into lagoon by cutting the berm between them

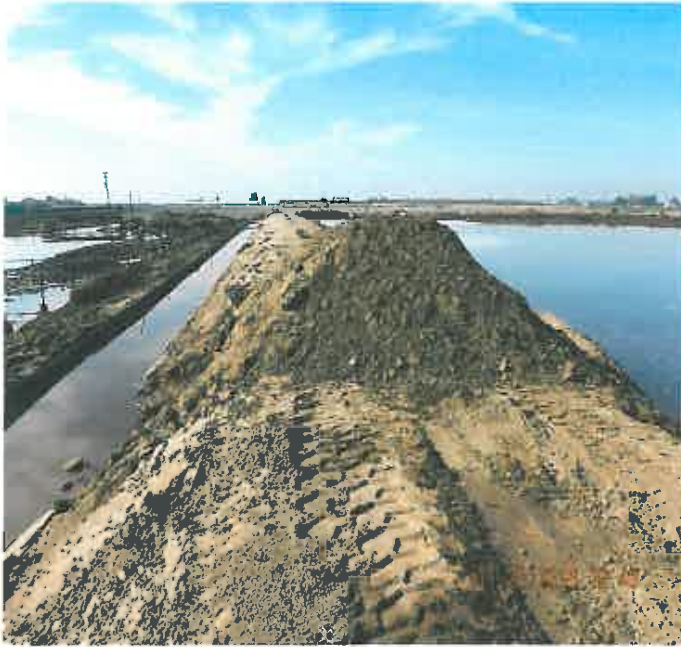
Based on our review of the available documents and field photographs of the breach, the breach appears to be a wash out failure of the berm as a result of water seeping along the interface of a buried pipe. From the photos, we estimate the breach appeared to be about 10 to 15 feet wide with nearly vertical side walls and the bottom of the breach extended to a depth of about 6 feet below top of the berm. The exact cause of the breach was unknown at the time of the failure. It is also our understanding that a 4-inch diameter PVC pipe (unknown to the property owner) and an electrical conduit (that extends to an existing pump located near the southeastern corner of the pond, and was also unknown to the property owner) were observed within the breached berm section (the 4-inch diameter PVC pipe shown in the field photographs at the time of the breach). A portion of the 4-inch diameter PVC pipe extended directly into the storage pond and appeared to have been buried by accumulated sediment within the pond. It should be noted that in a few of the photos of the breach, a small sinkhole is observed on the top of the berm; the sinkhole appears to have formed as a result of the loss of conduit pipe backfill during the breach.

Based on the results of our work, we conclude that the breach is the result of soil piping along the interface between the discovered 4-inch diameter PVC pipe (the pipe that was found extending into the pond within the breach area) and the surrounding soils.

Photo 17 The broken berm of the lagoon being repaired

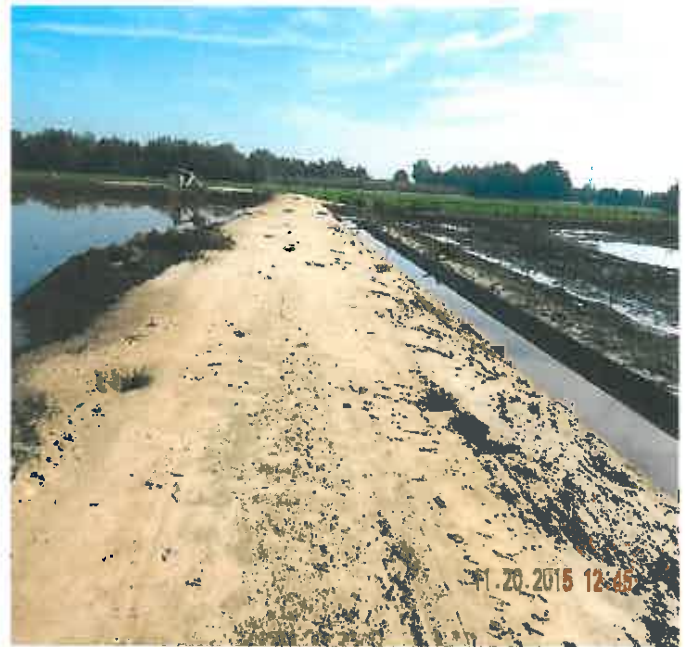
In addition to the analyzed conditions described previously, we performed a stability analysis of a condition where the outer 5 feet of berm is removed under high pond water height (water at the same elevation as the berm) and the berm is saturated. This analysis was performed to account for burrowing animal disturbance along the outboard sides of the berm. The analysis resulted in the similar static and earthquake factors of safety as Condition 3 shown in the table above. Therefore, this analysis indicates that rodent holes did not, and could not, cause the lagoon berm to fail.

Photo 18: Lagoon berm with holes:

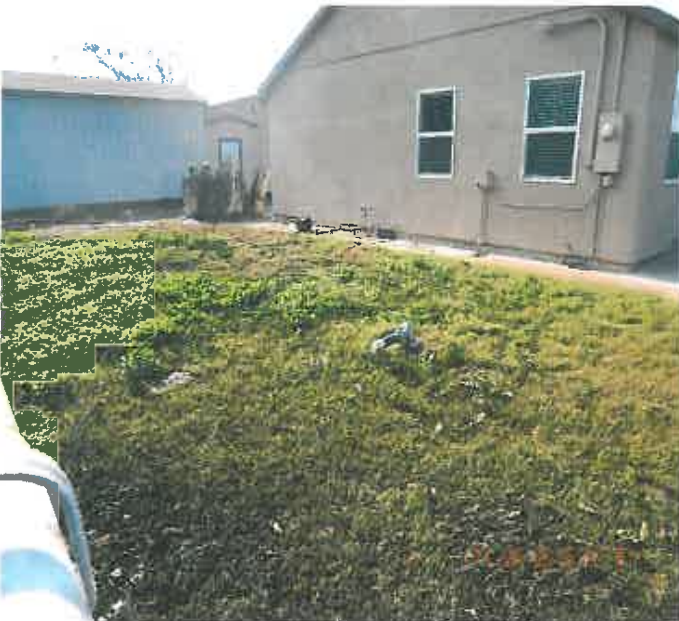
Photo 23: Wastewater reached groundwater well location

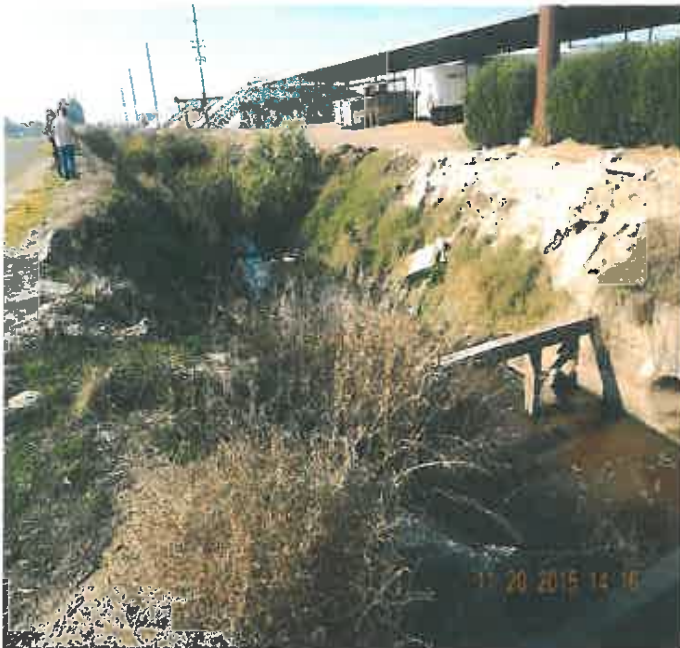
Photo 25: Wastewater in Harding Drain
